# Manhole Inspection Summary

Manhole # S39CC1021MH

Insp Date: **12/12/06 9:28 AM**

**Location** Address: **749 37TH**

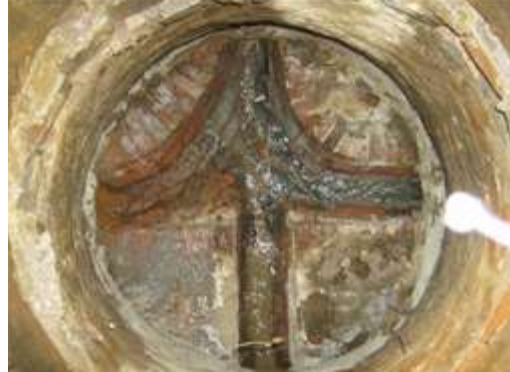
Top View

Corroded and missing steps. Evidence of surcharge - Bench debris. Channel debris.

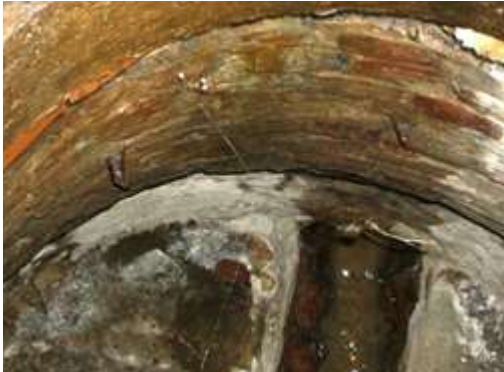
Defect

Frame leaks. Adjustment deterioration and infiltration - other side.

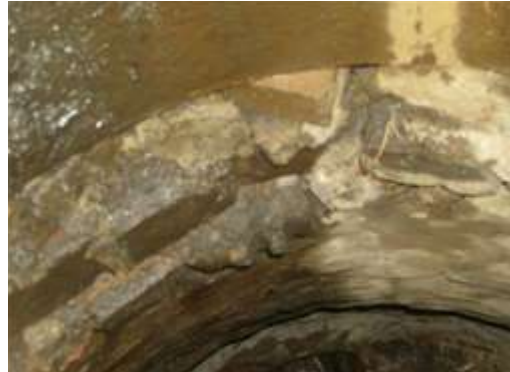
Defect

Frame leaks. Adjustment deterioration and infiltration.

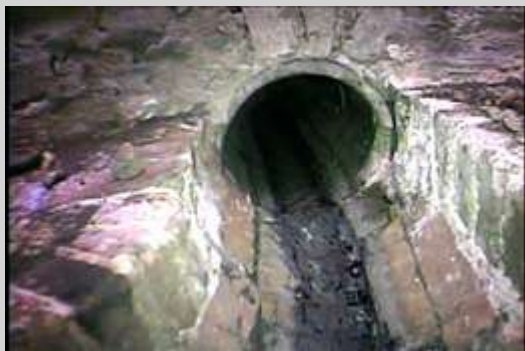
### 8 in. Circular Gravity Sewer Pipe In @ 3 O'Clock

Infiltration: **Evidence** Pipe Seal Cond: **Unknown**

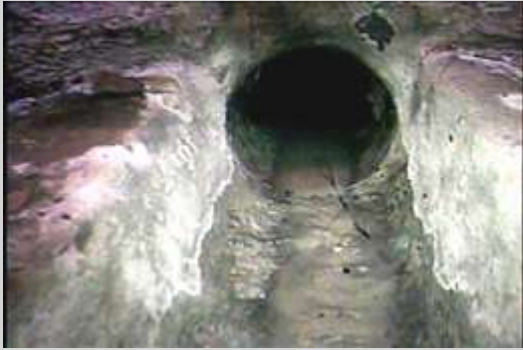
Pipe In @ 6 O'Clock

Deposits: ☐ None ☐ Mud ☐ Sludge ☐ Debris ☒ Grease

Silt Depth: **0** (in.) Deposits Extent: **Light**
